# Desalting controller RD-1

## Model 560-A

The RD-1 desalting controller, installed in the cupboard, limits and controls the conductivity of the water in the boiler. If this is within the limits allowed, the valve continually cleans the water to maintain the required levels of conductivity inside the boiler. If conductivity increases, reaching the maximum value permitted, this causes the alarm to switch on and / or the burner to stop.

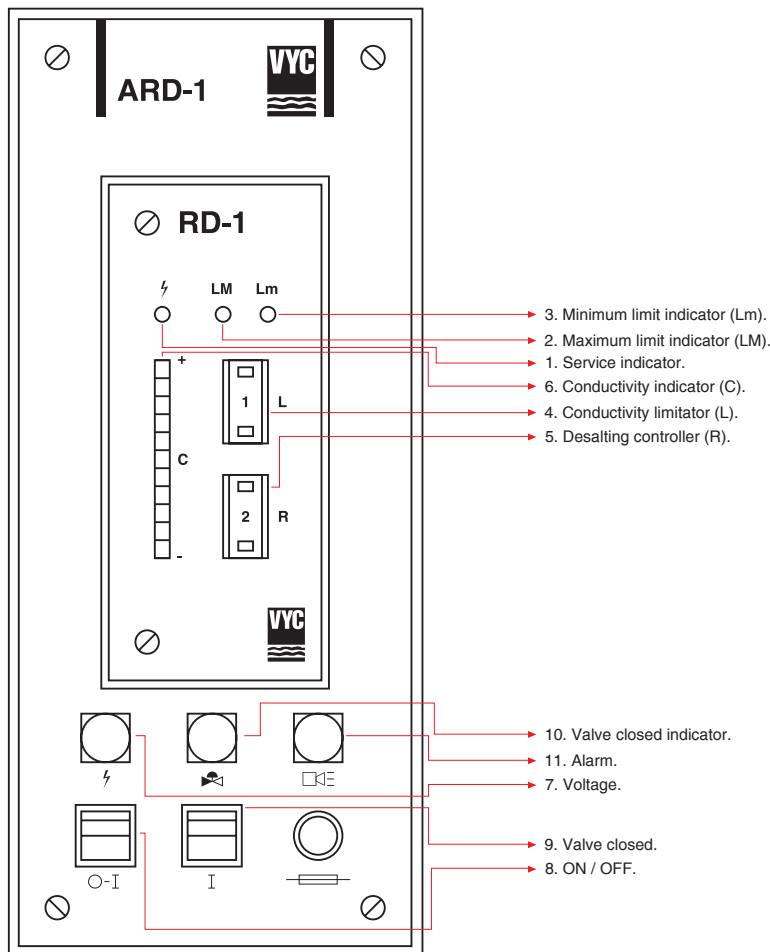
### 1. Description of the regulator

The position of the conductivity indicator (C) 6 shows us the real conductivity of the water inside the boiler. If the needle is inside the red area, this means that conductivity is excessively high, and the service indicator 1 cuts out, the alarm 11 is activated and, if required, the burner is stopped.

The 10 scaled positions of the desalting controller (R) 5 allow correct adjustment of the commutation point. Position 9 corresponds to the highest permissible conductivity, so position 0 allows a greater desalination.

The regulation of the continuous desalting valve, within the indicated value for permissible conductivity, is indicated by the maximum limit indicator (LM) 2 and minimum limit indicator (Lm) 3 lights.

When the appliance is switched on, regardless of conductivity, the servomotor opens the continuous desalting valve to clean out any static impurities. The maximum limit (LM) 2 and minimum limit (Lm) 3 indicators are connected and the conductivity indicator (C) 6 may be in any position. After about 60 seconds, the servomotor brings the valve to position 1 or 2, depending on the real conductivity of the water in the boiler. Only if the conductivity is higher than the maximum limit will the valve be completely opened, reaching position 3.

It is important that position 2b be set as the final working position. At the end of the day, turn on the valve closed switch 9. Once the valve is completely closed, the valve closed indicator 10 will light up, preventing any unnecessary loss of water. Then turn the valve closed switch 9 once more, as well as the on / off switch 8, to leave the boiler turned off.

The maximum limit (LM) 2 and minimum limit (Lm) 3 indicators will light up. The service indicator 1 will cut out and the conductivity indicator (C) 6 will move into the red area. Finally, the alarm 11 will go off and / or the burner will stop.
